MEMS acceleration sensors of automotive for Infrastructure Management

April 21, 2015 Akebono Brake Industry Co., Ltd. Sensor Solutions Department Takashi Kunimi

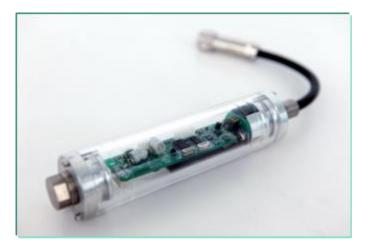
FIT Underground Inclinometer and

IT Ground Inclinometer

This new system enables to measure several points automatically with MEMS accelerometers

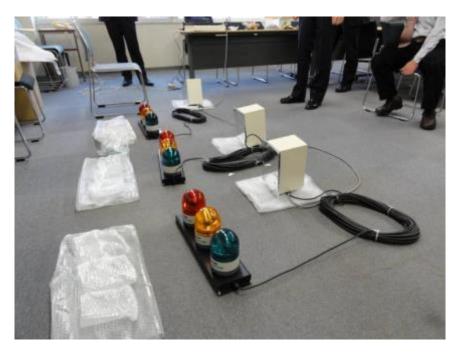
Light Emitting Inclination Sensor

A bridge girder was monitored as it got longer on each side. Every time concrete is casted on either side, the girder inclines responding to a new weight balance. The Light Emitting Inclination Sensors were installed to make sure that the inclination experienced during the construction process was within allowable range.

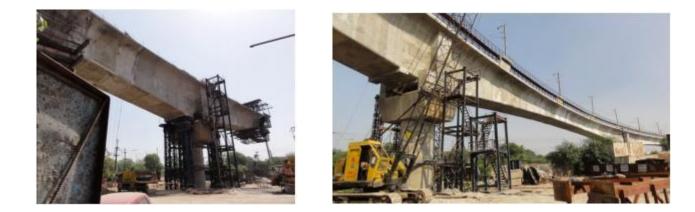
Japanese made sensors were installed by Indian engineers and local workers.

The inclination of the pier, which was initially anticipated to be negligible, was found to be NOT negligible. Its general trend suggested that the pier slowly but constantly tilted toward the inside the bridge curvature with the radius of 300m.
